## EXPED CALL FOR INSPECTION

Exped have reported that Lightning backpacks with LOT number 2210 have an irregularly sewn seam. There is a possibility that this may partially tear, causing the aluminium bar to damage the backpack.

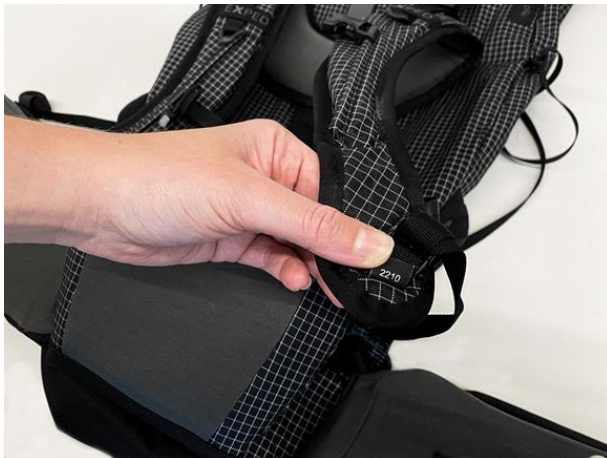
You can find the LOT number under the left shoulder strap:
